*Cold regions testing of an air-transportable shelter*

## *Cold regions testing of an air-transportable shelter*

Stephen N. Flanders

August 1981

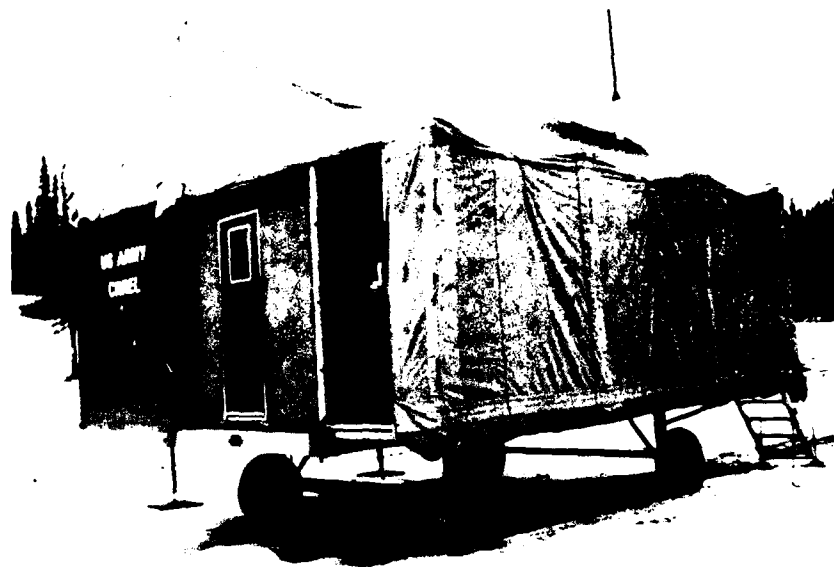
Figure 1. Fully erected shelter on site at Ft. Greely, Alaska.

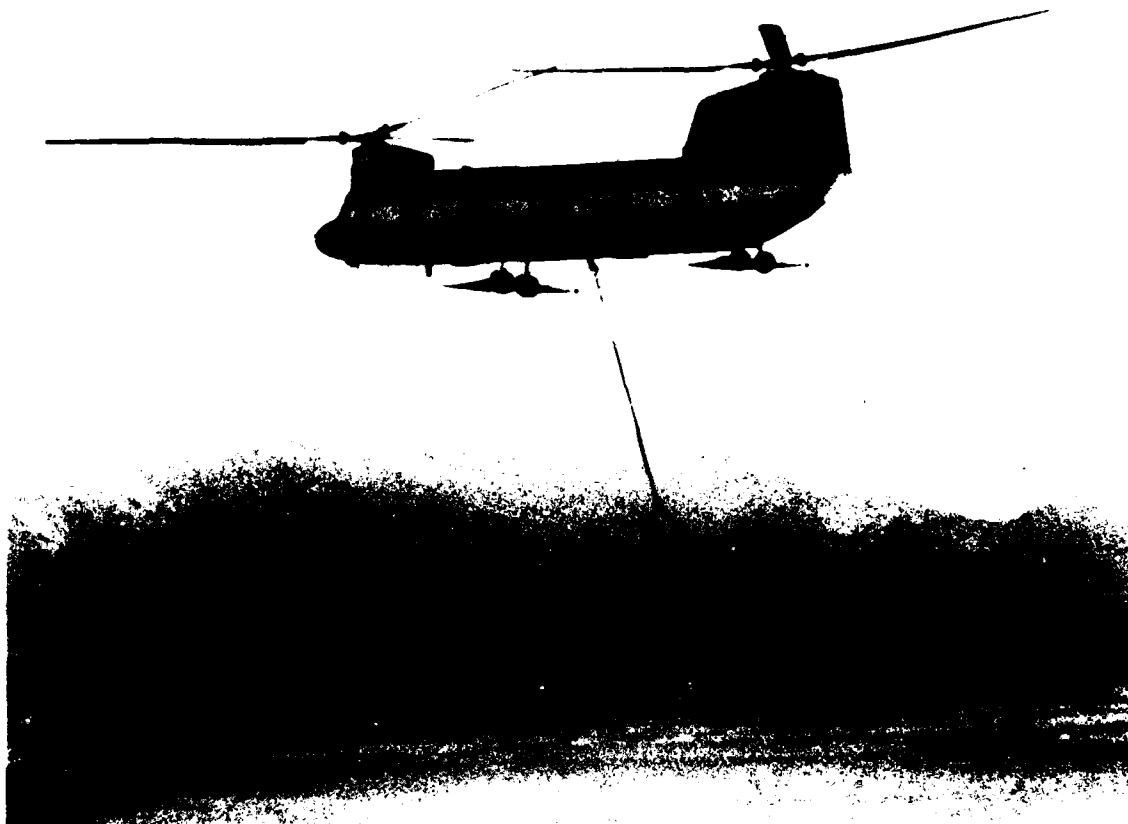
*Figure 6. Helicopter flight test of the CRREL shelter at Ft. Greely, Alaska.*

In hover, shown in Figure 6, the shelter rotated about its vertical axis. In forward flight the shelter flew fore-and-aft oriented until the helicopter executed a descending turn; thereafter it rotated and flew broadside to the direction of flight. The helicopter crew recommended a maximum airspeed of 80 knots for transporting the shelter. In sum, the flight crew considered the shelter to be very stable in straight and level flight and suitable for helicopter airlift (Dollahite 1978).
